CLOSURE REPORT
TEMPORARY ACCUMULATION AREA (TAA) 770
MARINE CORPS AIR STATION
EL TORO, CALIFORNIA

**Environmental Remedial Action
Contract No. N62474-98-D-2076
Contract Task Order 0024**

**Document Control Number 5127
Revision 0**

January 9, 2003

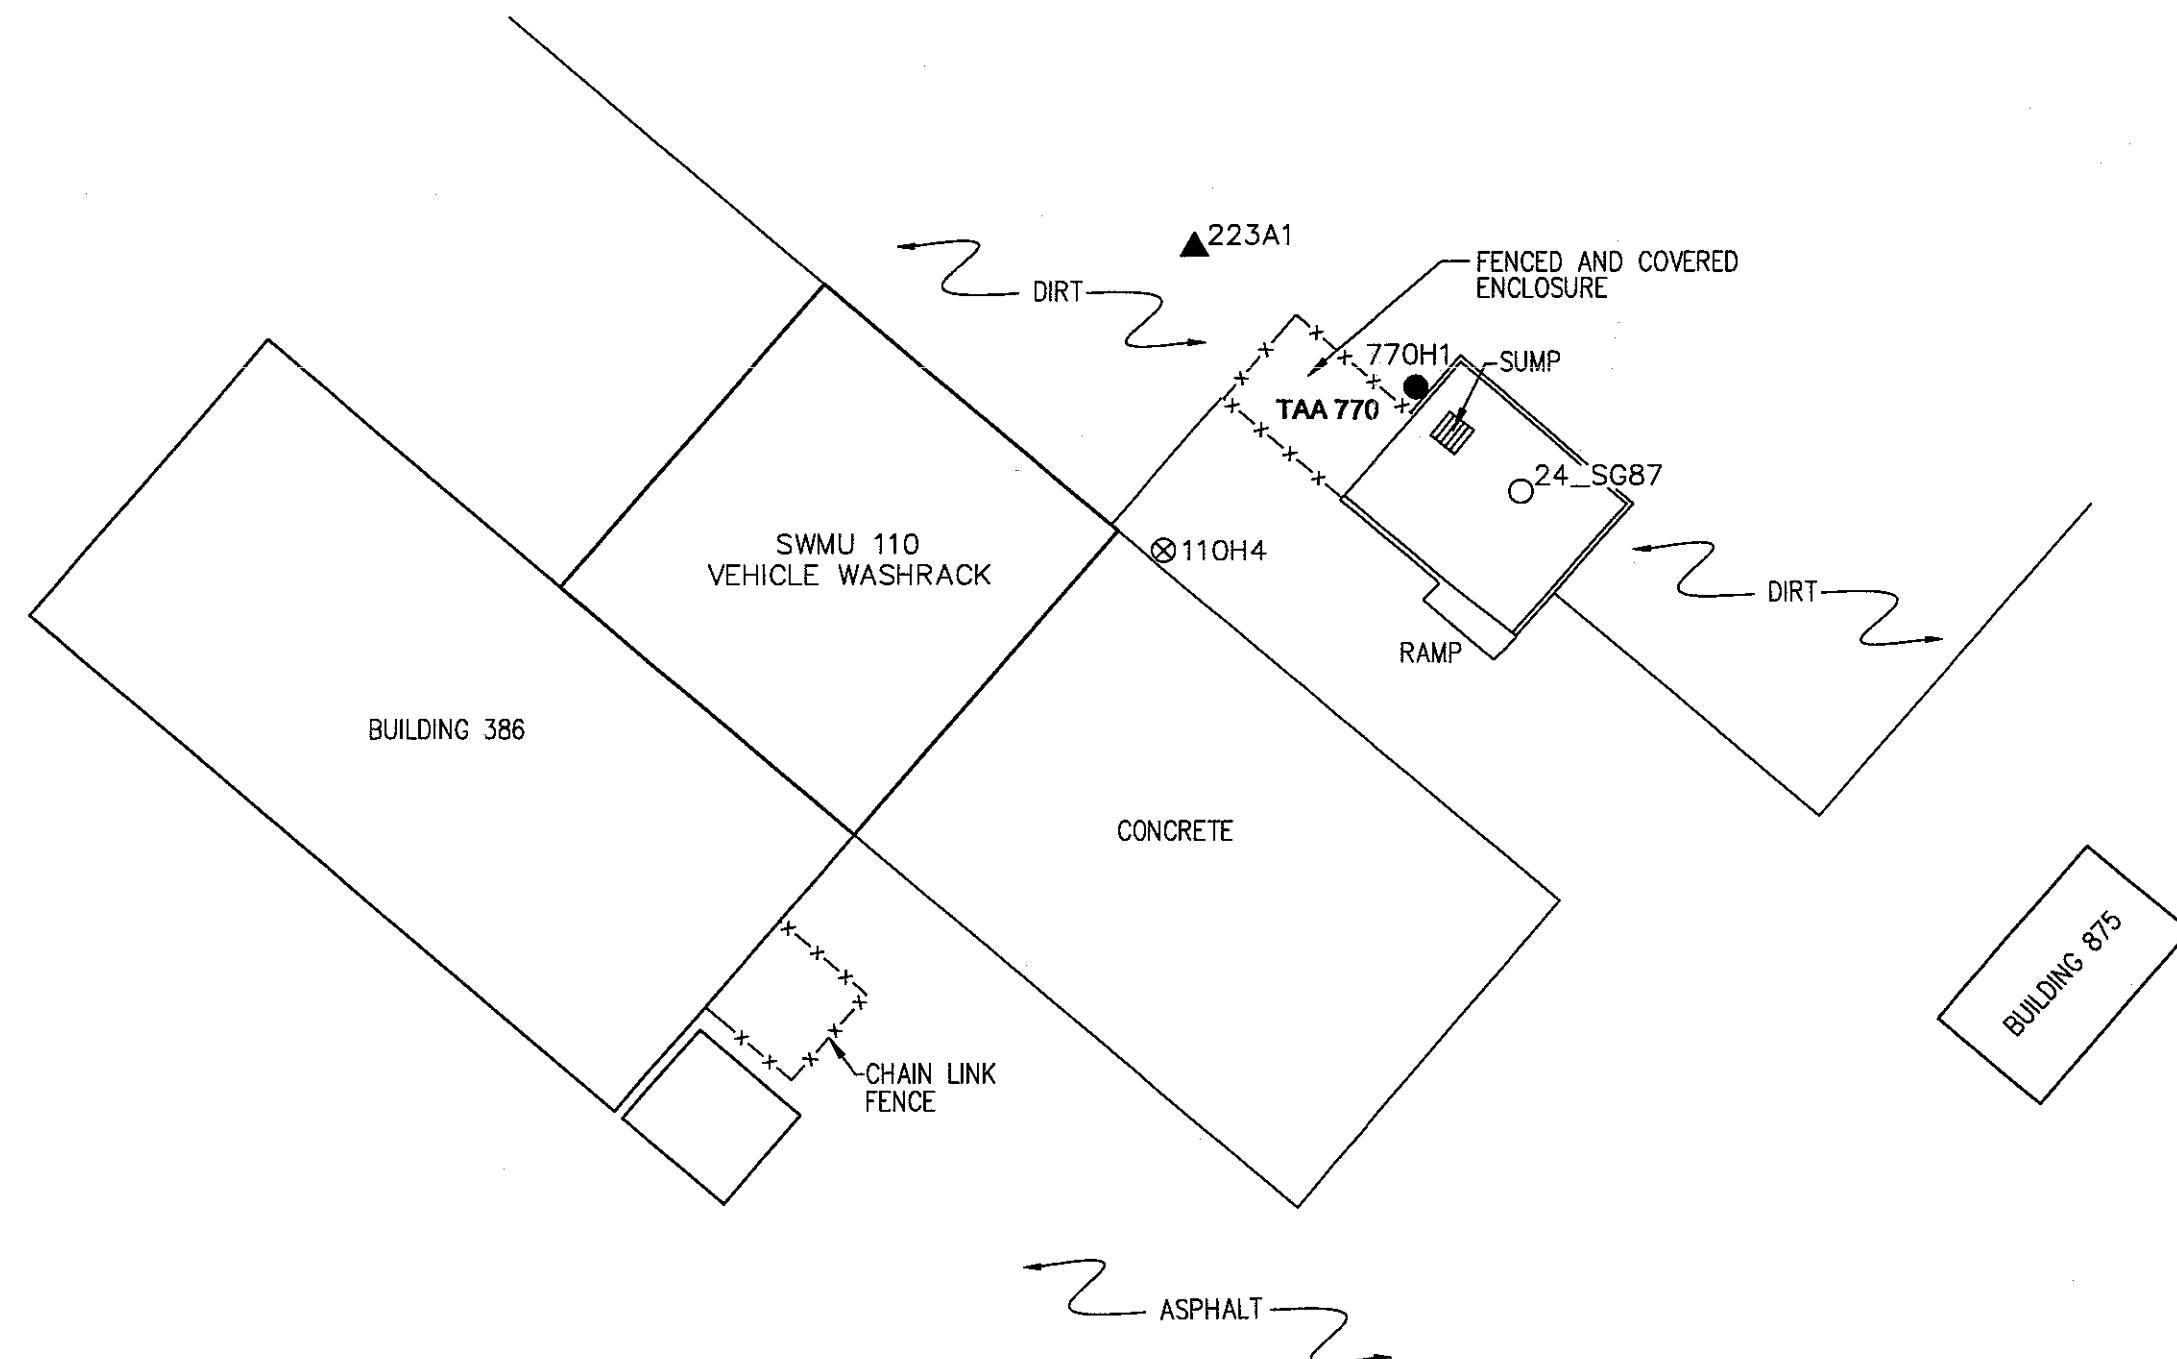
FIGURE 3-1
SITE PLAN
TAA 770

- ⊗ RFA 5' DEEP BORING
- ▲ RFA 60' LONG, ANGLE BORING
- IRP SITE 24 SOIL GAS LOCATION
- SOIL SAMPLE LOCATION (IT, 2002)

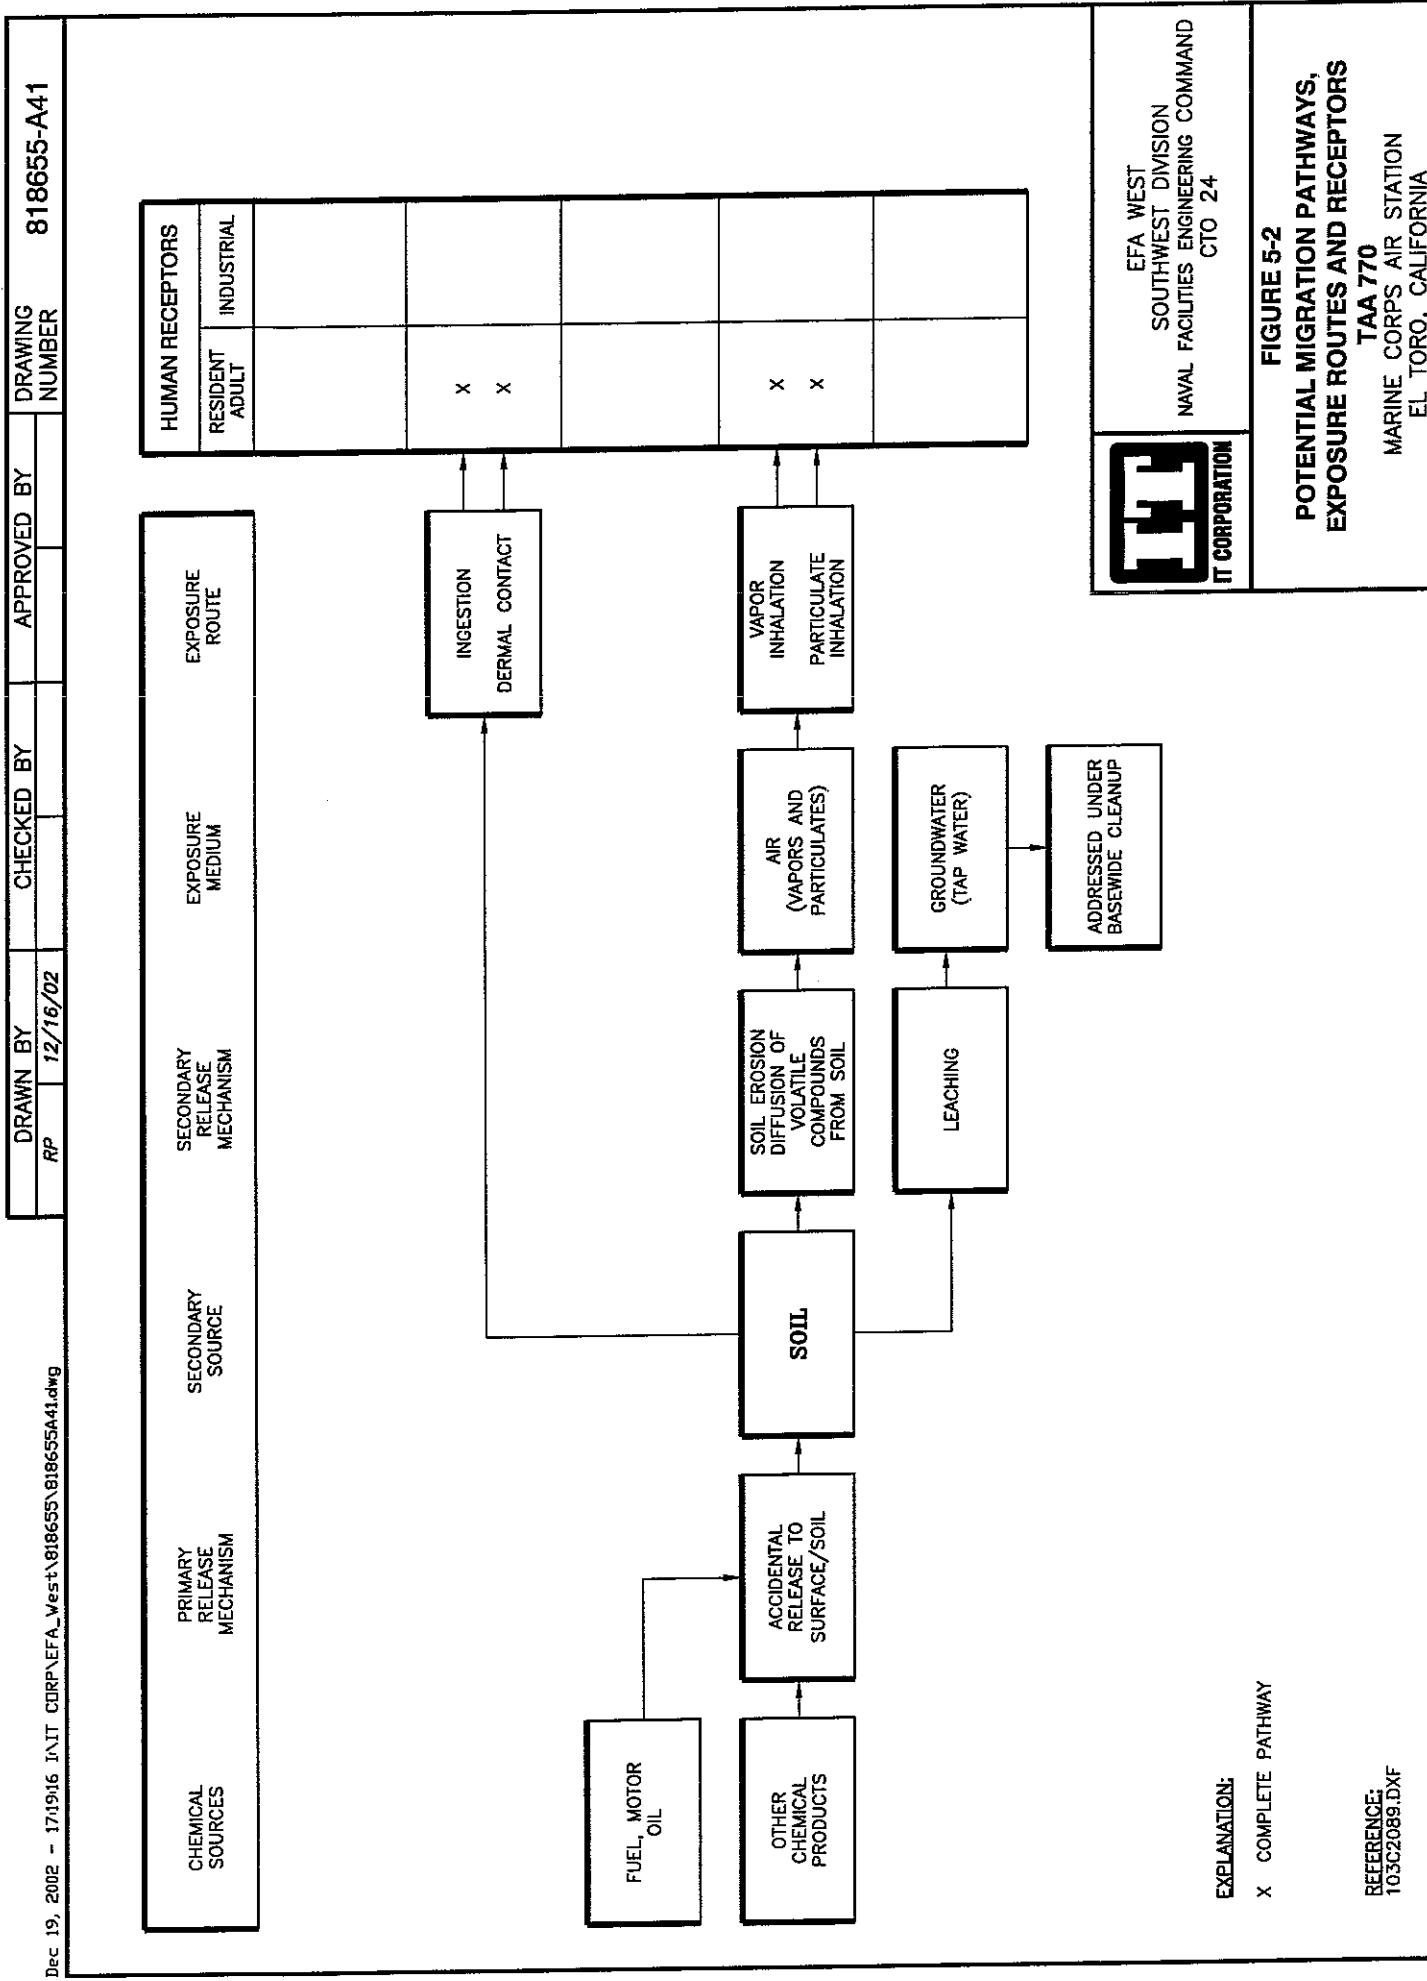
**FIGURE 5-2**

For screening purposes, the ingestion, dermal contact, and inhalation exposure pathways are assumed to be complete for former TAA 770, as if the area were unpaved. Should the screening fail, further evaluation of the exposure pathways would be required. A site conceptual model for former TAA 770 is shown on Figure 5-1.

POTENTIAL MIGRATION PATHWAYS,
EXPOSURE ROUTES AND RECEPTORS
TAA 770
IT CORPORATION

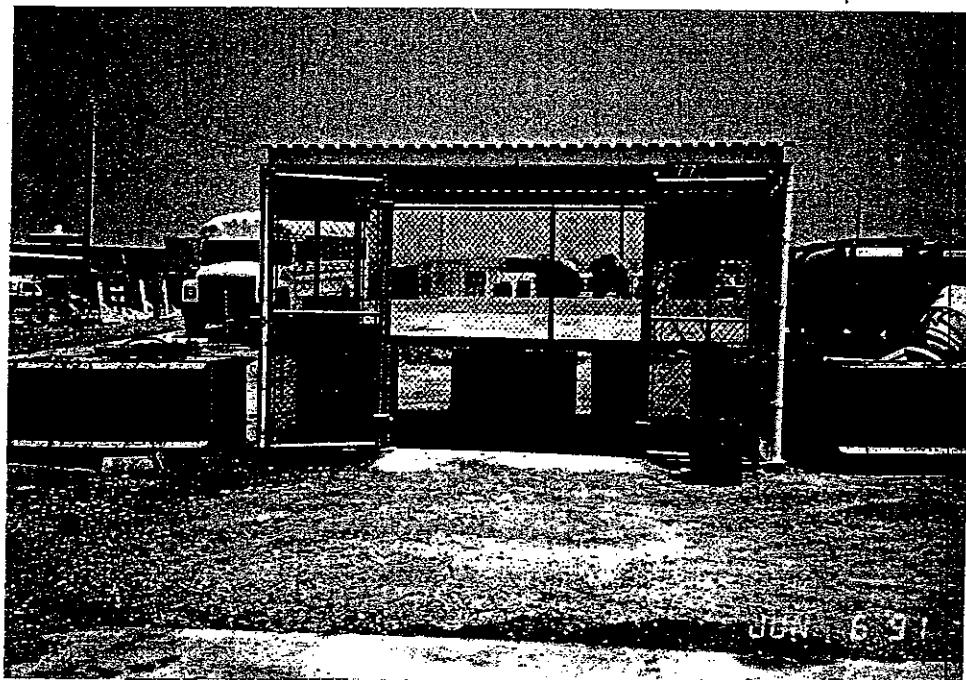
This Hazardous Waste Storage Area (HWSA) is one of the six DHS-permitted HWSAs at MCAS El Toro. These six HWSAs (SWMU/AOC Numbers 222 through 227) are not planned for future use. Historically, these six HWSAs have had drums stored outside of the storage area. This HWSA is located about 60 ft east of Building 386 near the southeast corner of a vehicle washrack (SWMU/AOC Number 110). It consists of a 12-ft by 12-ft concrete storage surface surrounded by a 6-in. concrete berm. A chain-link fence and aluminum roof protect the HWSA from unauthorized entry.

At the time of the site visit, the HWSA appeared as if it was being cleaned. All of the drums had been removed and placed on wood pallets outside the southwest corner of the HWSA. There was about 2 inches of water in the HWSA. No significant stains or cracks were observed.

Although there was no evidence of a release during the site visit, the past and present HWSAs at MCAS El Toro are recommended for a sampling visit.

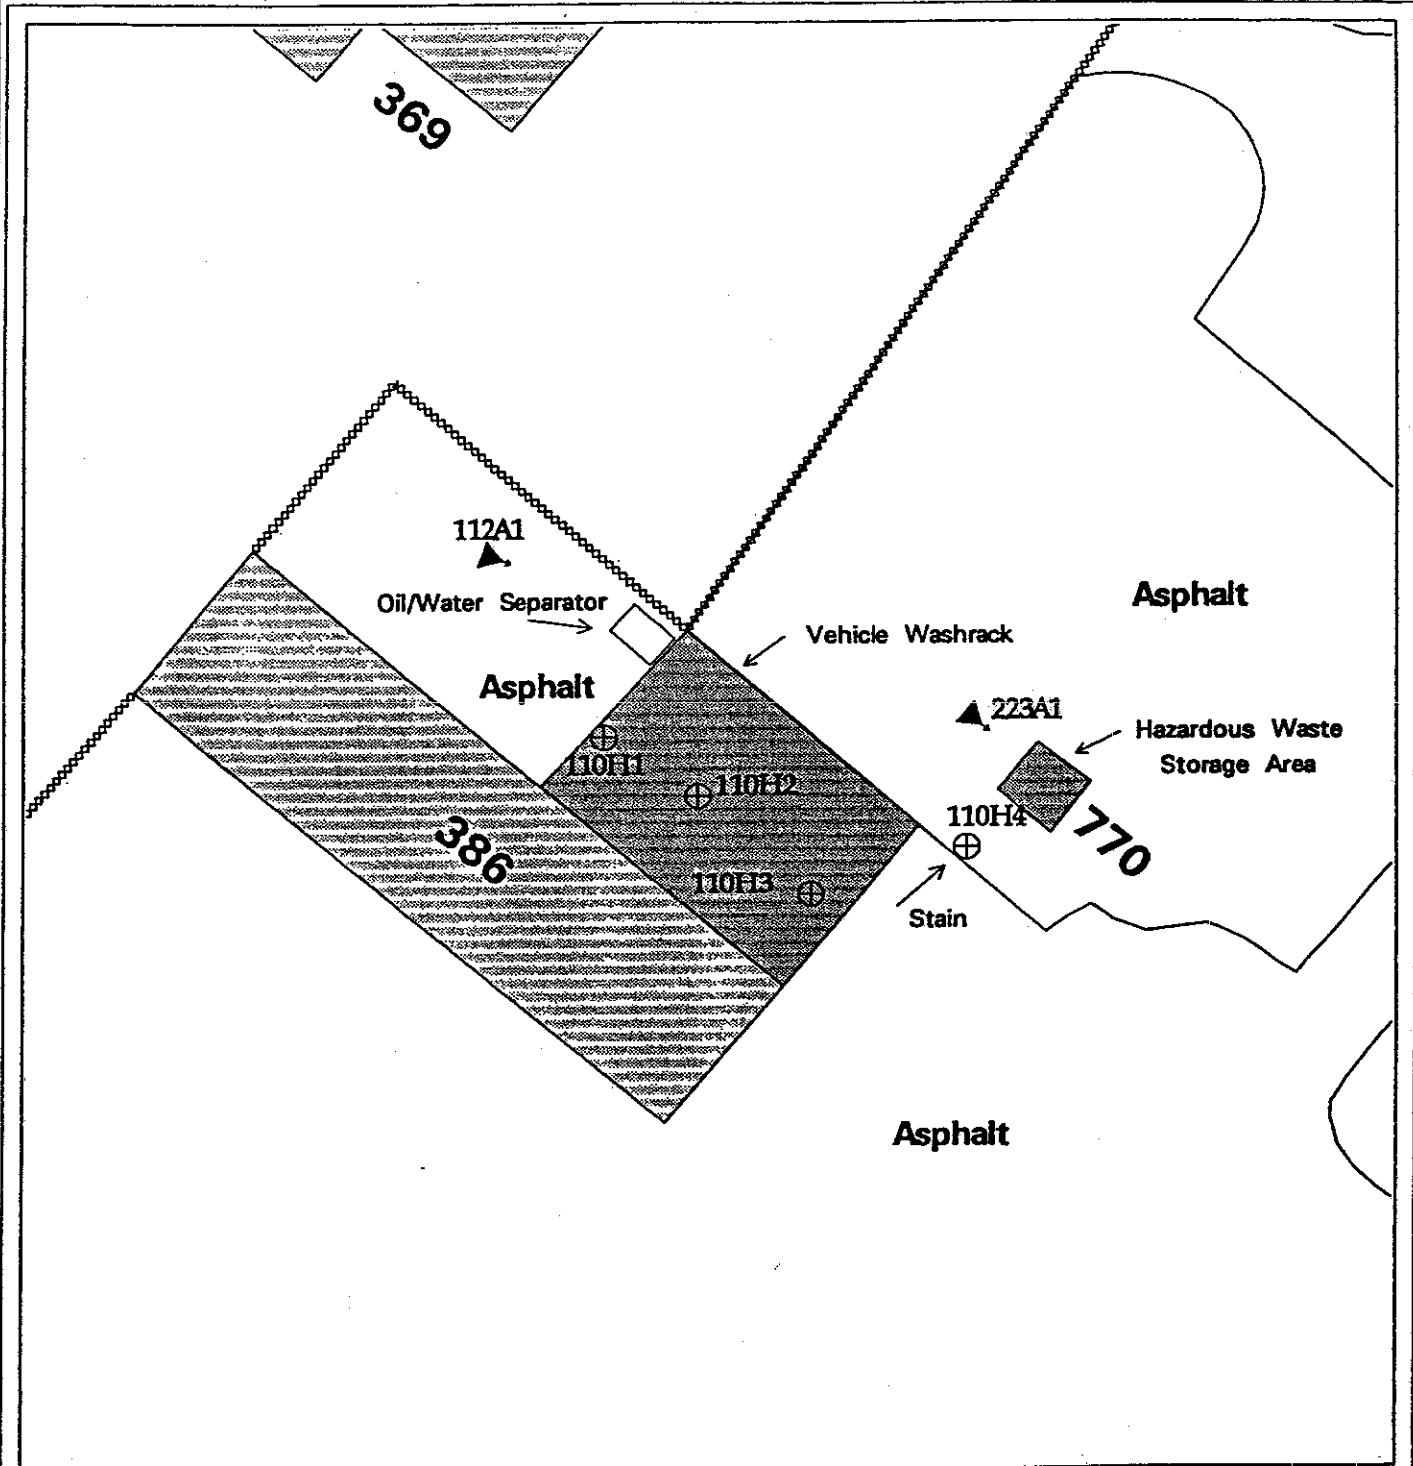
Figure 35 Sample Location Map

- 110 - Vehicle Washrack
- 112 - Oil/Water Separator
- 223 - Hazardous Waste Storage Area

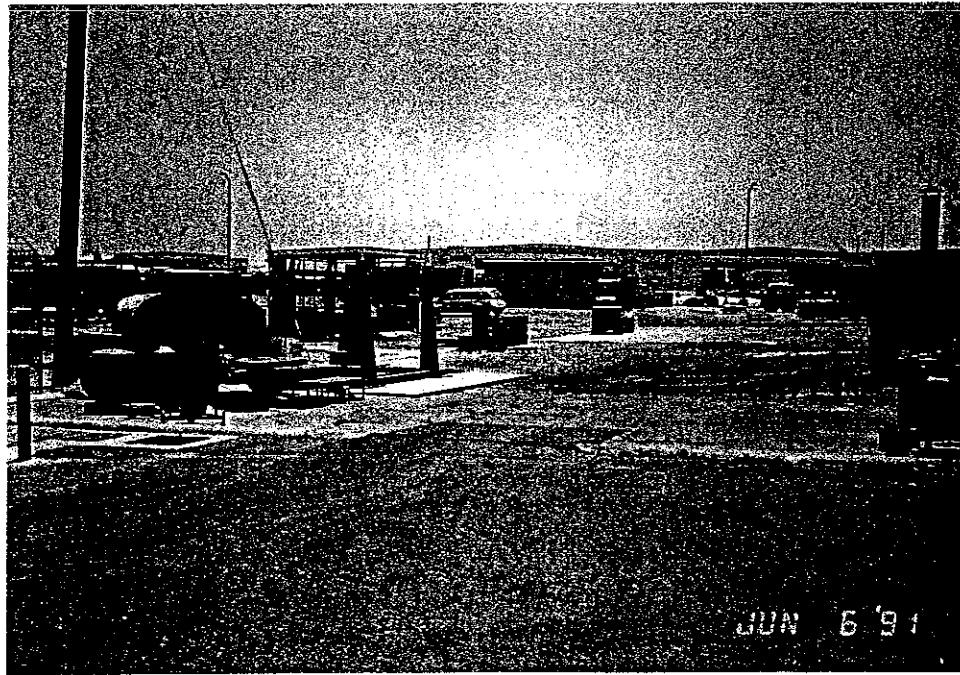
The washrack consists of a concrete wash surface surrounded by a 4-in. concrete berm. The washrack is graded so that all the water flows toward a drain situated in the center of the wash area. The drain leads to oil/water Separator 386-B. The wash pad is badly stained from vehicles being worked on inside the wash area. There are also several cracks in the wash pad where water could possibly leak through to the soil beneath the washrack. A portion of the berm has been removed from the southwestern corner so that vehicles can easily be driven into the wash area. It is unlikely that any water would flow away from this area because it is upgradient from the drain. The southeastern corner of the berm is also badly cracked. There are several stains on the ground outside this corner.

A 500-gallon bowser is stored in the northeastern corner of the washrack. The bowser is used to store waste oil. The bowser is elevated about 3 ft, therefore it is possible for a spill to spread outside the washrack berm. Two drip pans, located next to the bowser, are used to drain oil filters before disposal. There are several dark stains on the washrack's surface next to the bowser and the drip pans.

A hydraulic lift is located next to the bowser. From the stains around the hydraulic lift, it is evident that the hydraulic lift is still used.

Stained wash pad and stained ground outside the washrack

Based on the stains and cracks in the concrete, this washrack is recommended for a sampling visit.

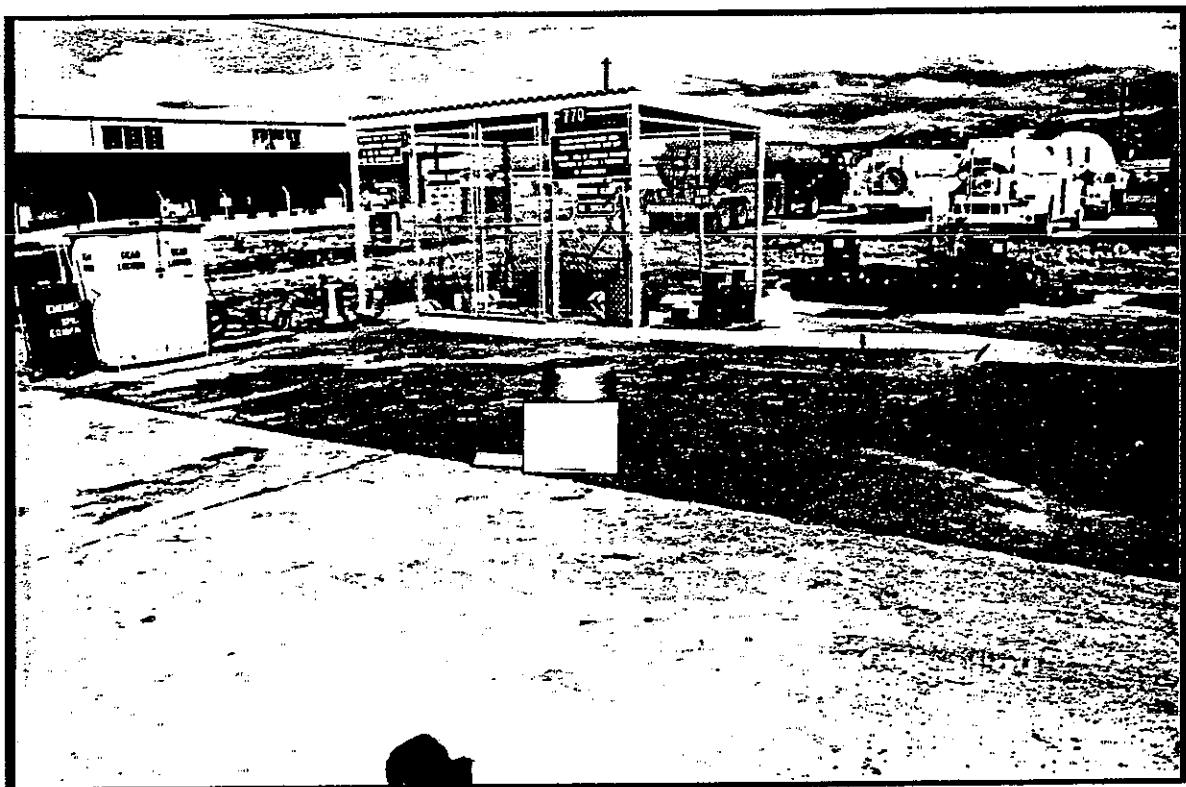
SWMU #: 223

During the BNI VSI on December 1994, former TAA 770 was observed to be a 40-foot by 10-foot, concrete pad with berm. Three drums were observed on a rack on the concrete pad. Very minor spots on the concrete pad were observed during the site visit (BNI, 1996). BNI did

"Stain(s)": Very minor spots on open pad area.

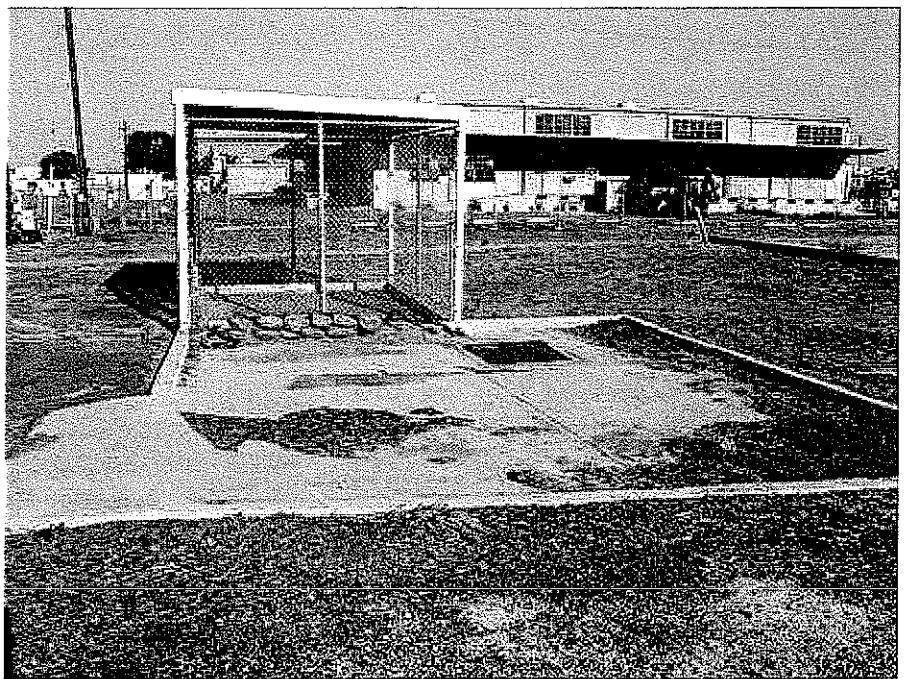
View of TAA 770

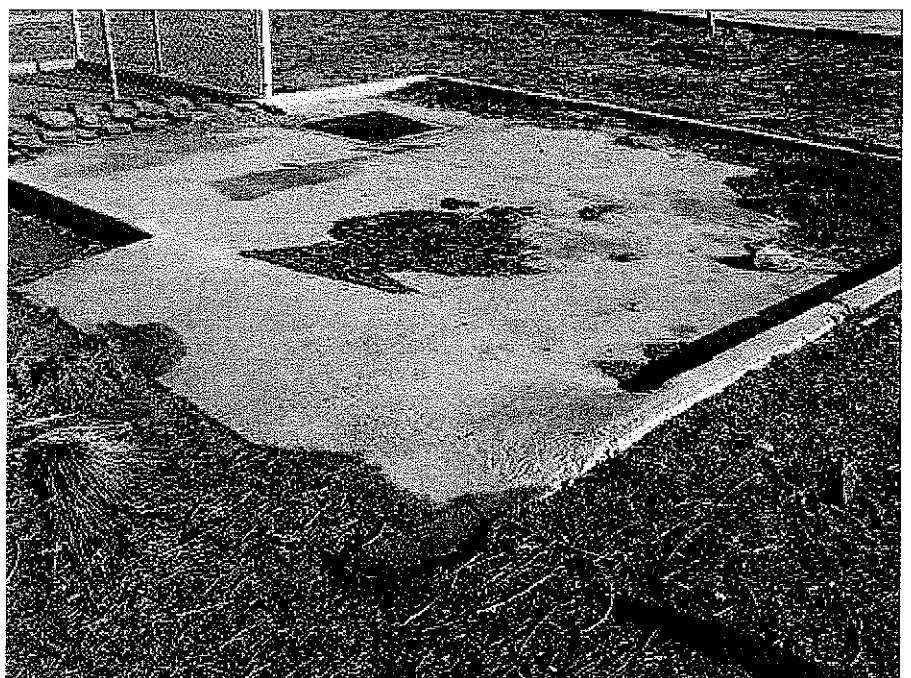
Former TAA 770 was inspected by OHM/IT in 1999. Former TAA 770 was observed to be an inactive TAA, consisting of a concrete pad with concrete berm. The surface of the concrete pad was clean and intact without any major cracks. No evidence of a release was observed around the former TAA 770. A photo log of former TAA 770 is included in Appendix H. A copy of the Site Assessment Log is included as Appendix I.

TAA 770 with clean concrete pad and sump.

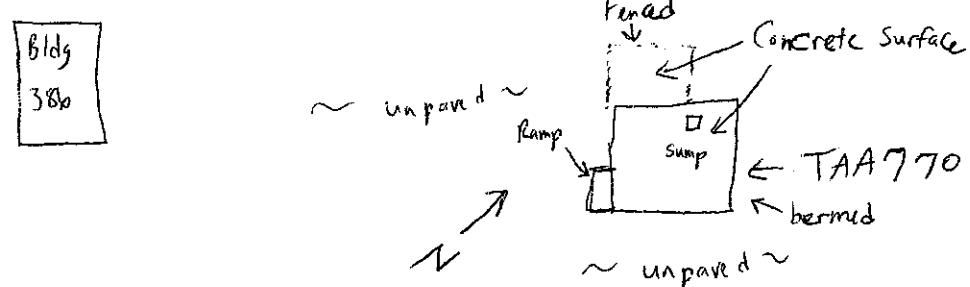
Draw Sketch:

TAA area: *Concrete floor and berm appear in good condition with no stains or major cracks.*
